Ten-Tec Jupiter (Model 538)

Low-pass Filter Relay & Reverse Polarity Repair

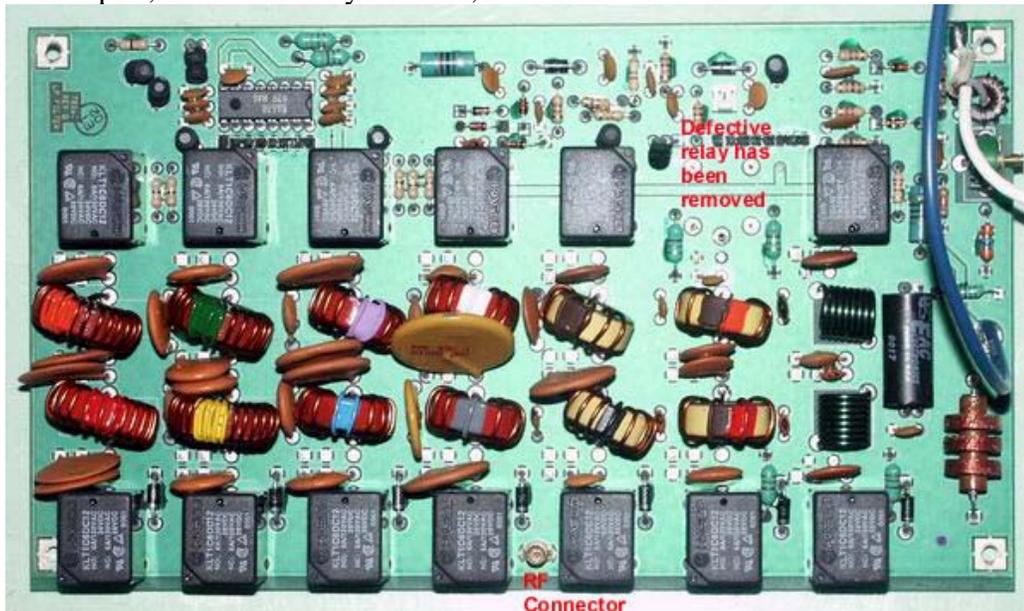
The Jupiter rig belonging to Gary VE7GGJ would not transmit on 15/17 metres. All other bands transmitted and received flawlessly.

Low-pass filter board with 15 of 16 relays installed (the defective 17/15 metre band relay has been removed)

If the resistance is approximately 400 ohms this indicates that one of the relay coils is open! (In the unlikely event that BOTH relay coils are open the resistance would approach infinity.)

Carefully unsolder and remove one of the suspect relay pairs and measure the coil resistance. If the coil is open this relay must be replaced.

Measure the coil resistance of the relay remaining on the low-pass board for the band under test. A working relay should have a coil resistance of approximately 400 ohms. A relay with an open coil **MUST** be removed and replaced.

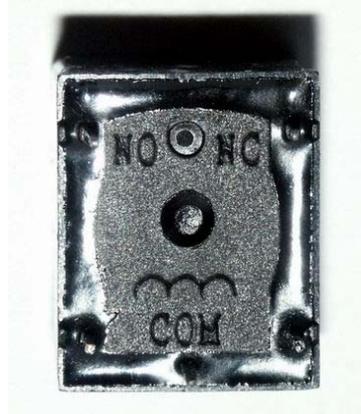
Each relay has 5 pins and with 3 pins at one end and 2 pins at the other end. As indicated in the figure, the **relay coil** contacts are located on either side of the relay **common** pin.

Relay – Coil and common connection are at the bottom of the figure

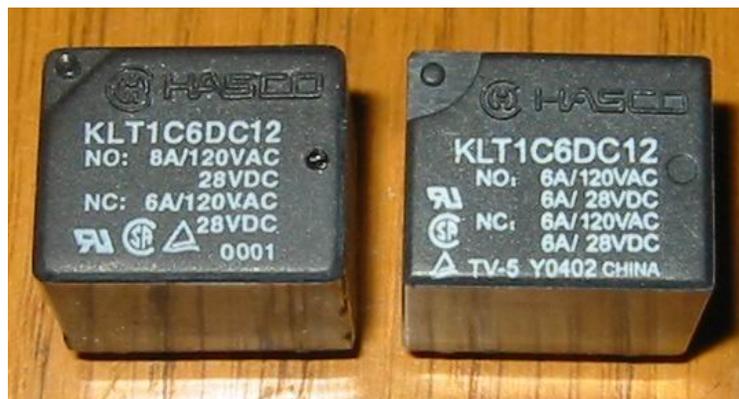
Contact Ten-Tec Service for the necessary replacement relay(s) (**Ten-Tec Part Number 32103**). Consider ordering a spare so you're ready if this happens again. The old (left) and new (right) relays are shown in the following figure.

Test the new part(s) before installing them to make sure that the coil is operational (for a new relay the coil resistance should be approximately 400 ohms). With the new parts installed check all the relays before reassembly to ensure that the coil resistance for each band is approximately 200 ohms.

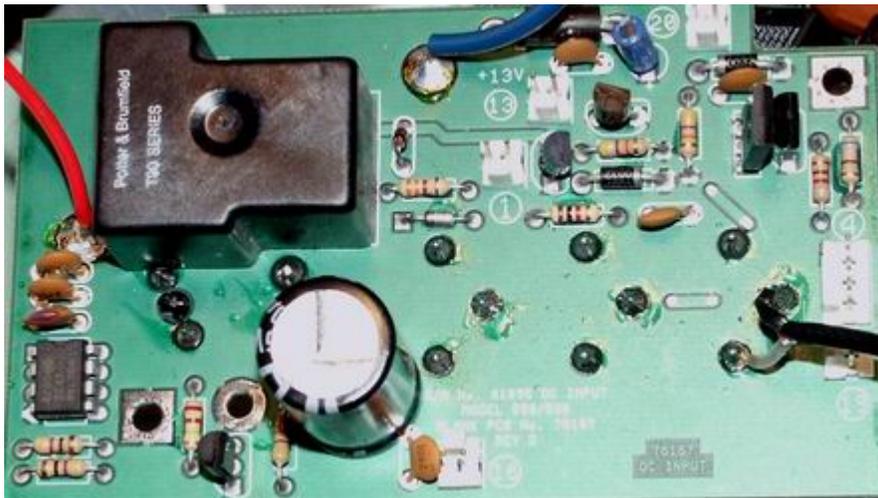
An unintended repair was needed when, after a 3rd relay failed, a change of ALL switching relays was completed. It was getting late and the power supply leads to the Ten-Tec Jupiter were inadvertently reversed. The result was smoke and a completely dead Jupiter.

After some research the problem was tracked down to the DC Input board (78187). The solution was, fortunately, fairly easy and inexpensive – whew. Transistors Q1 and Q2 were replaced (they are next to connectors 1 and 13) with 2N2222 transistors and the Jupiter was back in business. (**Note:** The RG-174 coax at the lower right of the DC input board has been added to allow the use of an RX-320 as a secondary receiver using N4PY software and may not be present.)
