# Ten-Tec Jupiter (Model 538)

## Low-pass Filter Relay & Reverse Polarity Repair

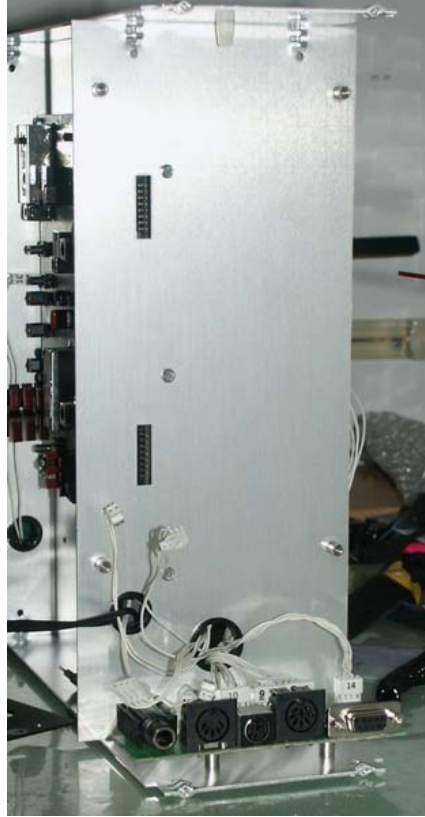
Note the two vertical slots with multi-pin connectors to accommodate the low-pass filter board. The **Rear Connectors board**, shown at the bottom of the photo, does not require removal.

Also the cable filled hole above the **Ext Speaker** connector is where the speaker cable from the top cover is routed.

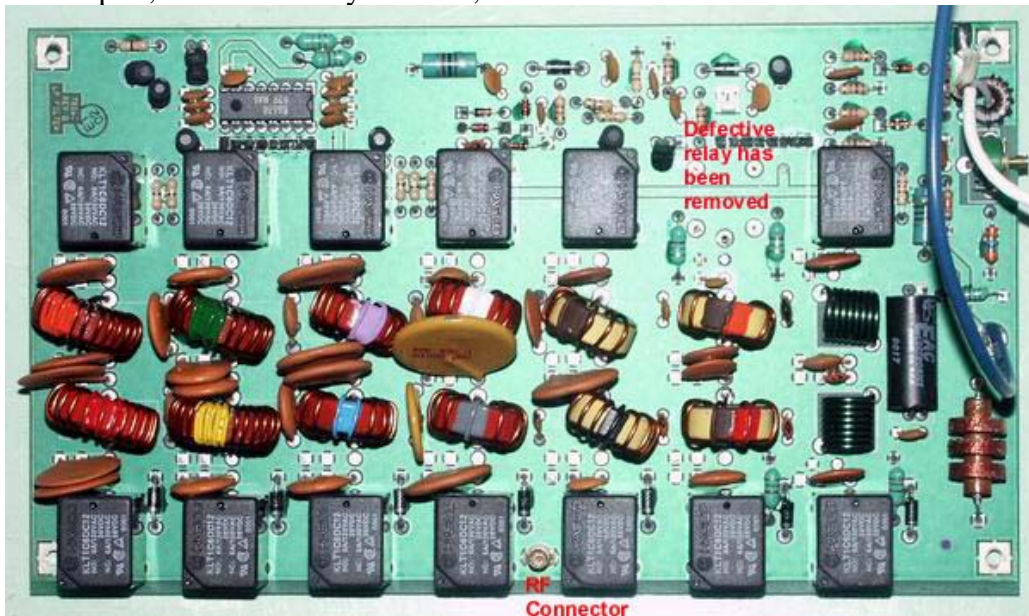
The low-pass filter relays are in two banks. One bank located near the edge of the board and its counterpart, located directly above it, near the board center.

Low-pass filter board with 15 of 16 relays installed (the defective 17/15 metre band relay has been removed)

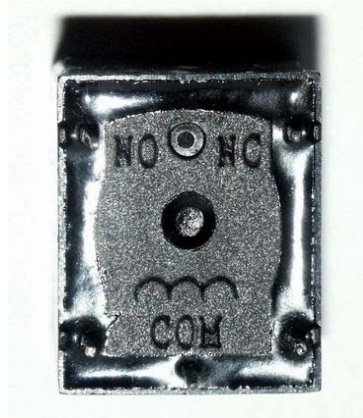
Each relay has 5 pins and with 3 pins at one end and 2 pins at the other end. As indicated in the figure, the **relay coil** contacts are located on either side of the relay **common** pin.

**Relay – Coil and common connection are at the bottom of the figure**

Each band combination has a pair of relays and the relay coils are wired in parallel. Measure the resistance across either of the band relay coils. The resistance should be approximately 200 ohms.

If the resistance is approximately 400 ohms this indicates that one of the relay coils is open! (In the unlikely event that BOTH relay coils are open the resistance would approach infinity.)

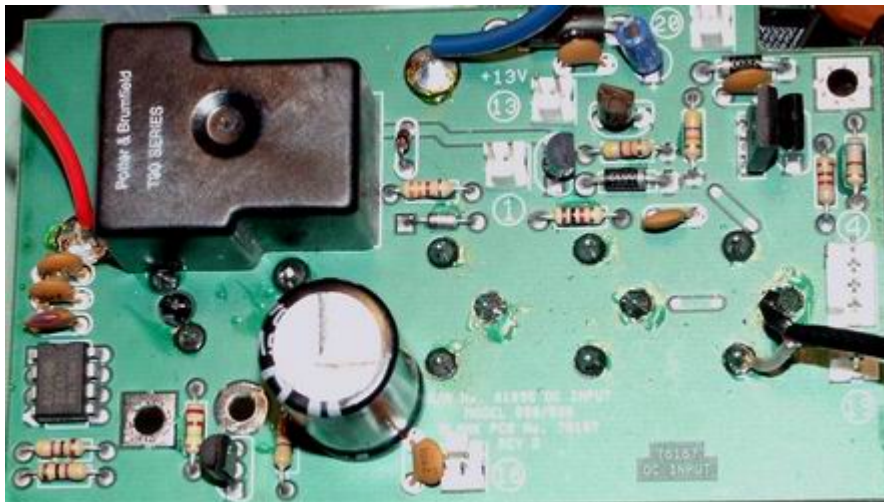
An unintended repair was needed when, after a 3<sup>rd</sup> relay failed, a change of ALL switching relays was completed. It was getting late and the power supply leads to the Ten-Tec Jupiter were inadvertently reversed. The result was smoke and a completely dead Jupiter.

After some research the problem was tracked down to the DC Input board (78187). The solution was, fortunately, fairly easy and inexpensive – whew. Transistors Q1 and Q2 were replaced (they are next to connectors 1 and 13) with 2N2222 transistors and the Jupiter was back in business. (**Note:** The RG-174 coax at the lower right of the DC input board has been added to allow the use of an RX-320 as a secondary receiver using N4PY software and may not be present.)
