Ten-Tec Jupiter (Model 538)

Low-pass Filter Relay & Reverse Polarity Repair

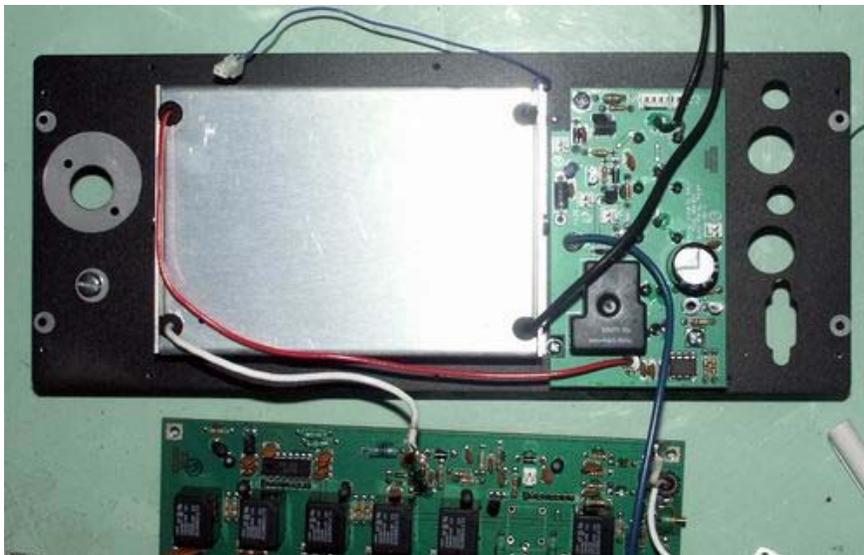
Rear panel with low-pass filter board attached

7. Remove the screws holding the low-pass filter board in place and **gently** unplug it from the 2 multi-pin connectors and remove it from the rig. (Note: Use caution as this board is still connected to the power amplifier assembly, DCIN assembly and the Jupiter back panel.)

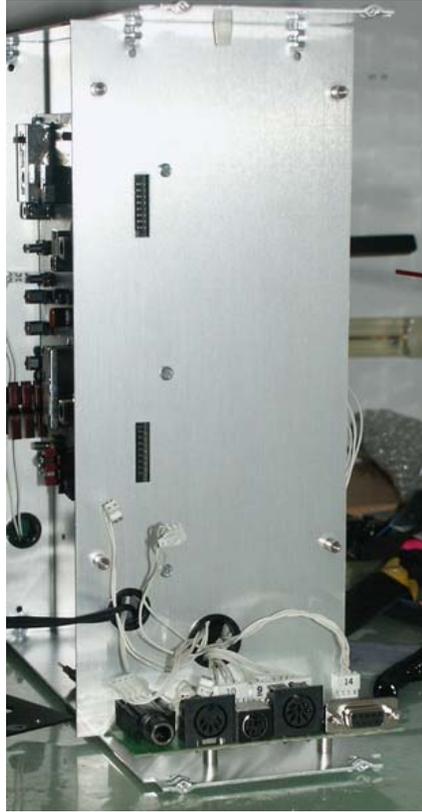
This figure is a rear view of the Jupiter on its left side with the back panel, DCIN board, Power Amplifier and low-pass filter board removed.

Note the two vertical slots with multi-pin connectors to accommodate the low-pass filter board. The **Rear Connectors board**, shown at the bottom of the photo, does not require removal.
