# Ten-Tec Jupiter (Model 538)

## Low-pass Filter Relay & Reverse Polarity Repair

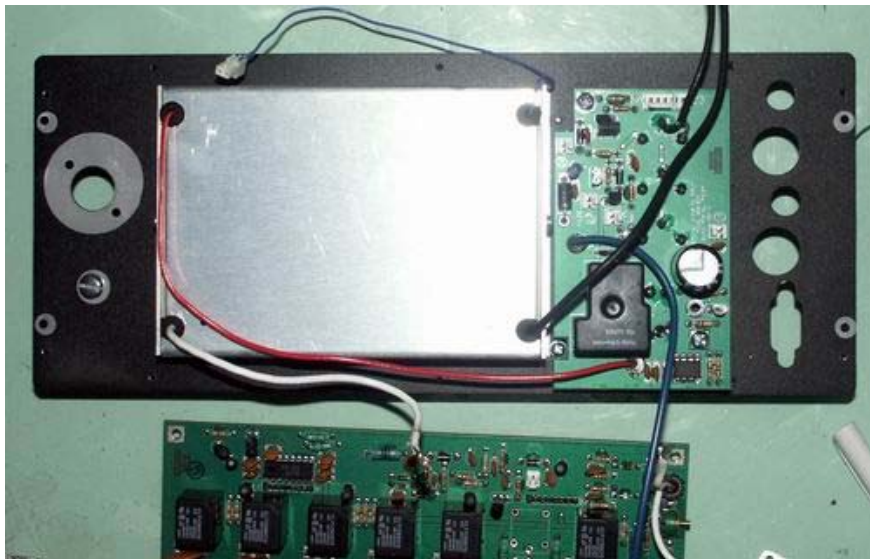
**Rear panel with low-pass filter board attached**

7. Remove the screws holding the low-pass filter board in place and **gently** unplug it from the 2 multi-pin connectors and remove it from the rig. (Note: Use caution as this board is still connected to the power amplifier assembly, DCIN assembly and the Jupiter back panel.)
